Re: August 2014 Monthly Progress Report  
Administrative Settlement Agreement and Order on Consent for Removal Action  
U.S. EPA Region 10 Docket No. CERCLA 10-2009-0255  
Gasco Sediments Site within the Portland Harbor Superfund Site

Attachment A      Monthly Visual Monitoring Report for Pilot Cap Vicinity

## Visual Observations Log Form

**Monitoring Period:** Monthly (Year 8)—August 2014

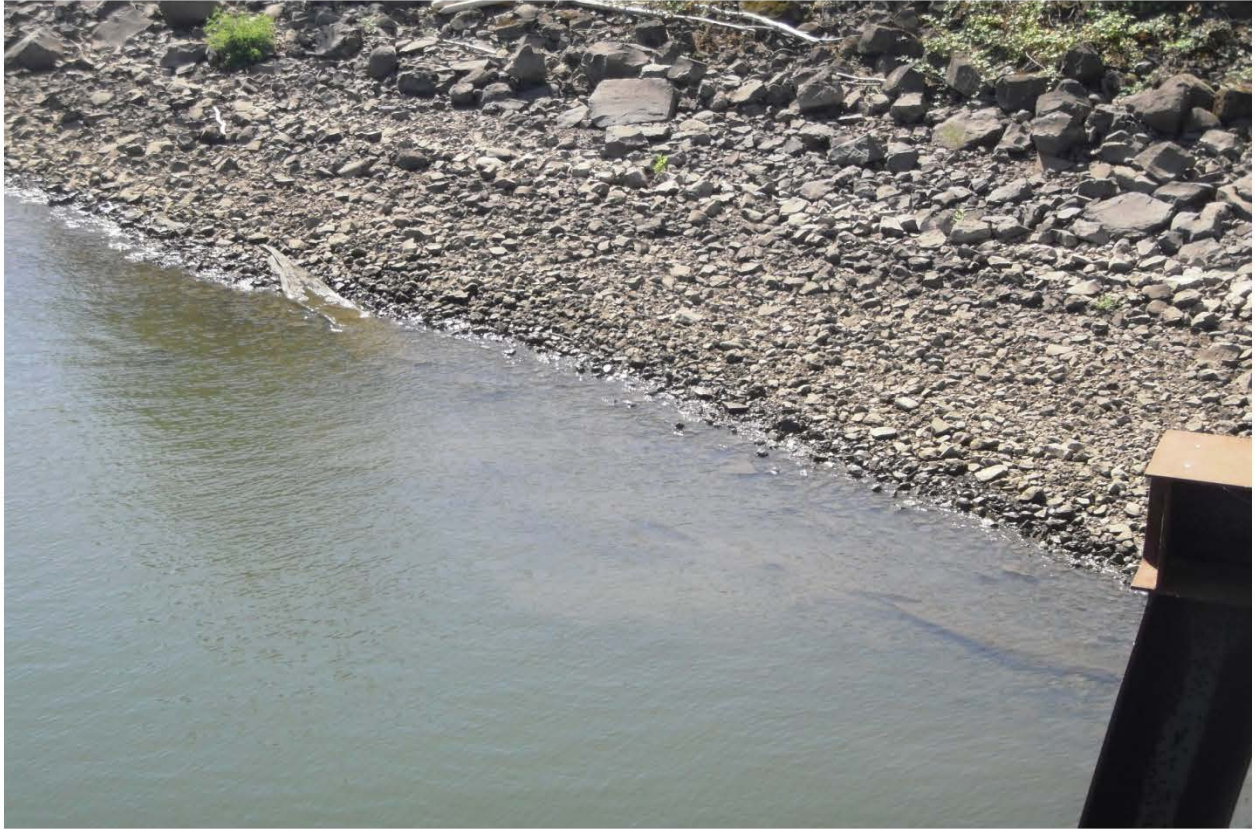
**Observations of Erosion/Deposition:** No erosion/deposition is evident along the shoreline. Three organoclay mat material segments are visible along the shoreline. One segment measuring 5-foot in length is submerged within 1.5 to 2.0 feet of the water's edge near the lateral mid-point of the cap area; one 20-foot section measuring 5 to 10 feet in width is above the water line at the upriver extent of the cap area; and one section of organoclay mat material measuring approximately 40 feet long by 5 feet wide is visible near the downriver extent of the cap area (Photo 1).

Photo 1 — *Visible section of organo-clay mat at the downriver extent of cap area (8/27/14):*

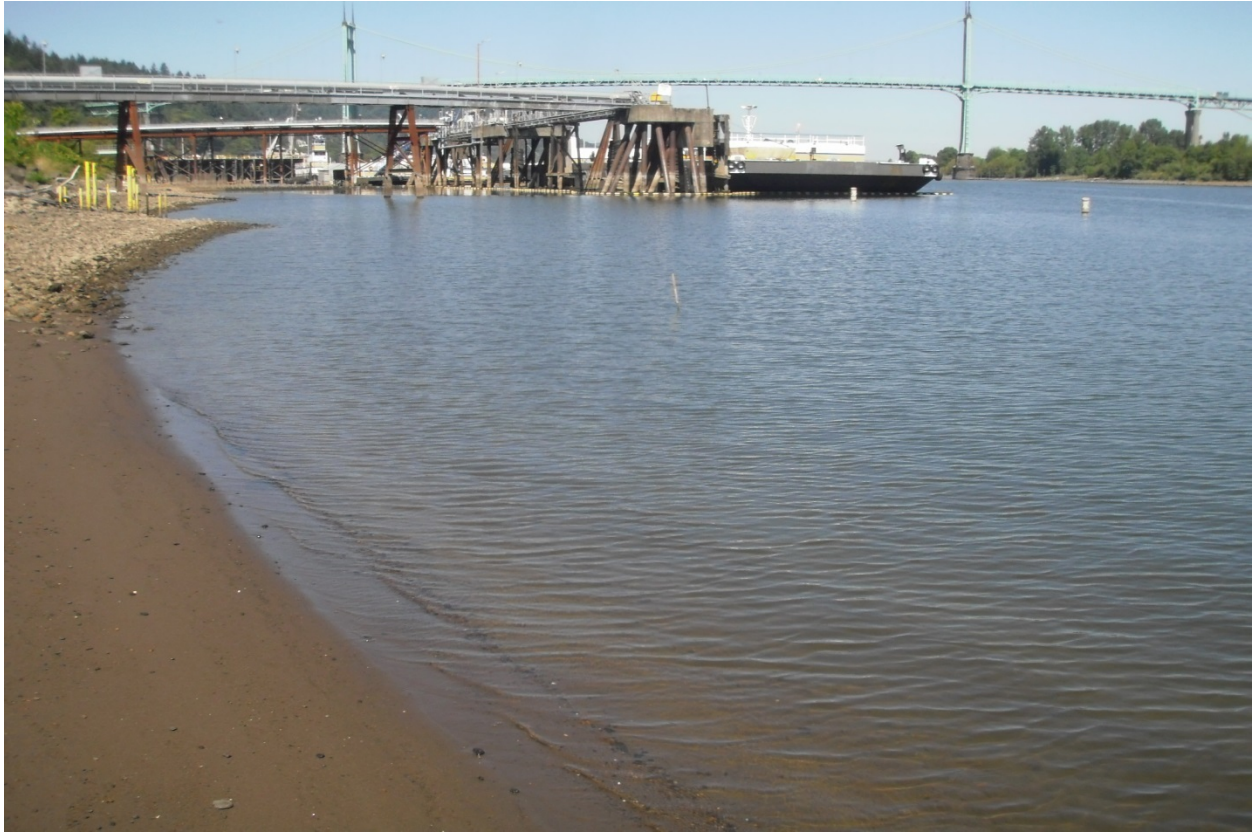
**Observations of Long-term Controls (i.e., oil booms, organo-clay mat, etc.)** During the observation, the Fuel and Marine Marketing (FAMM) containment boom was in use during refueling operations at the facility dock. Buoys that identify the cap area to mariners are in place as installed. The position of the FAMM oil boom, warning buoys, and a general overview of the site shoreline is shown in Photo 2.

Photo 2 — *FAMM oil boom around barge and mariner warning buoys in place across pilot cap area.*  
(8/27/14):

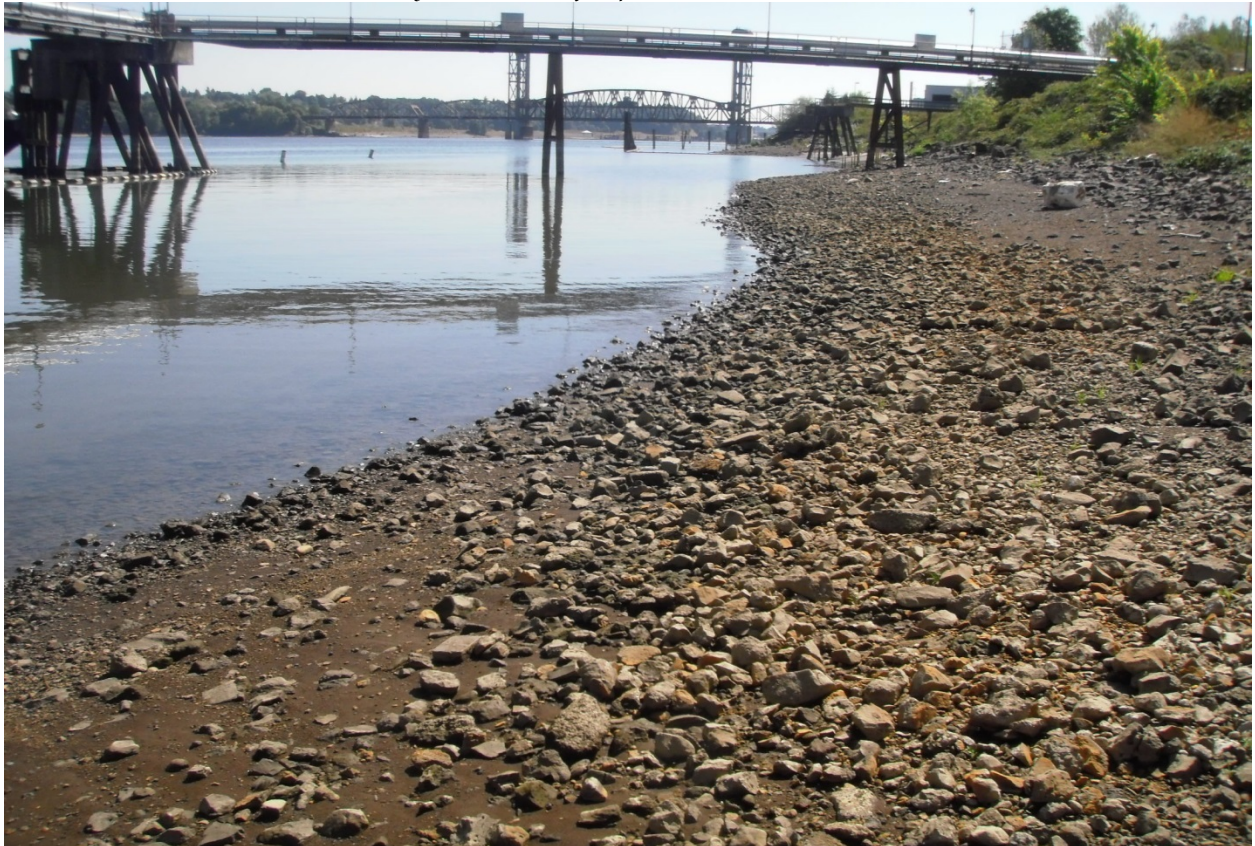
No sheen is evident in or around the cap area. Photo 3 shows the water surface and shoreline immediately downriver of the sediment cap.

Photo 3 — *Conditions immediately downriver of cap area* (8/27/14):
